Inspection Report

Property Address:
Sample Inspection Report
Stillwater MN 55082

Paladin Inspection Services

Date: 1/31/2015	Time:	Report ID: 150202Sample
Property: Sample Inspection Report Stillwater MN 55082	Customer: Joe Lundequam	Real Estate Professional: Joe Lundequam Paladin Inspection Services

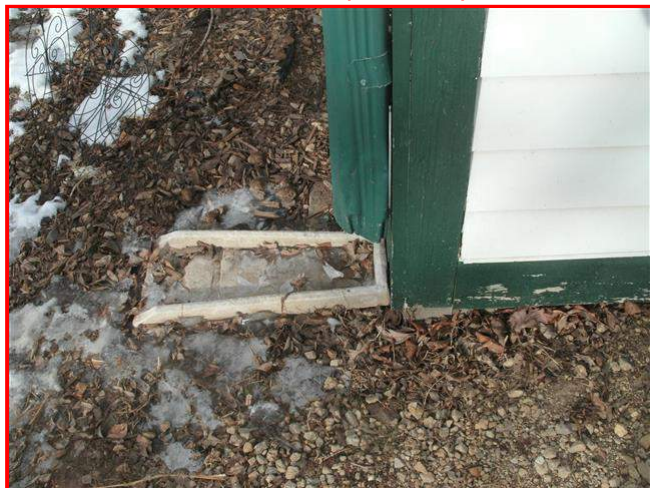
1.3 Item 1(Picture)

The downspout missing part (S) at the front (left of main entry). Erosion can continue or become worse if not corrected. A qualified person should repair or replace as needed.

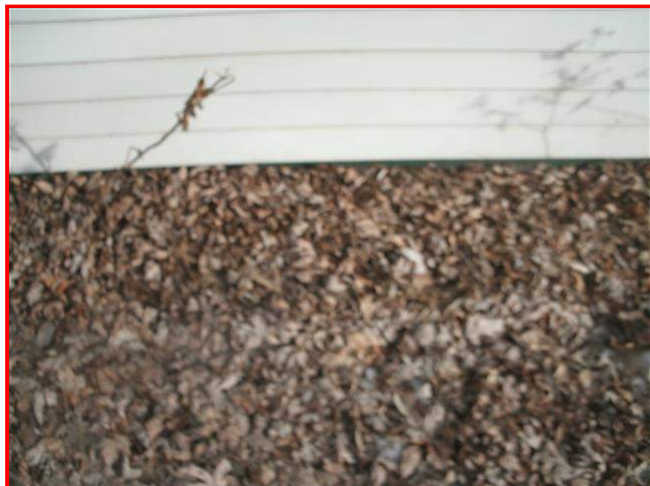
2.0 Item 1(Picture)

Siding should be 6" above grade. Recommend creating swale and removing soil from base of exterior walls.

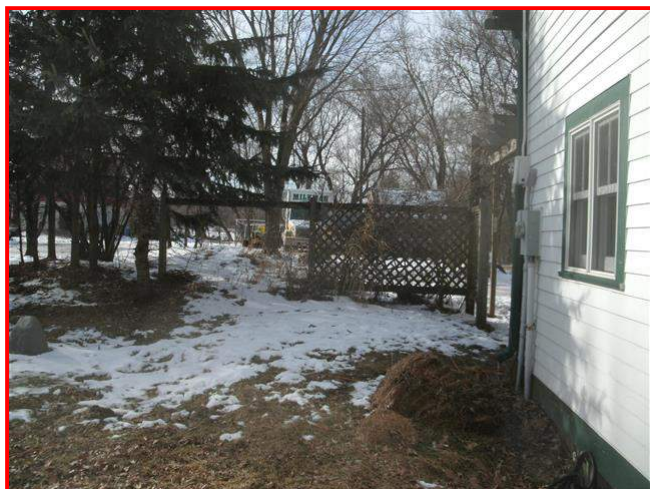
2.4 Item 1(Picture)

- 🐿 (1) There is a negative slope at the left side (facing front) and can cause or contribute to water intrusion or deterioration. I recommend correcting landscape to drain water away from home.

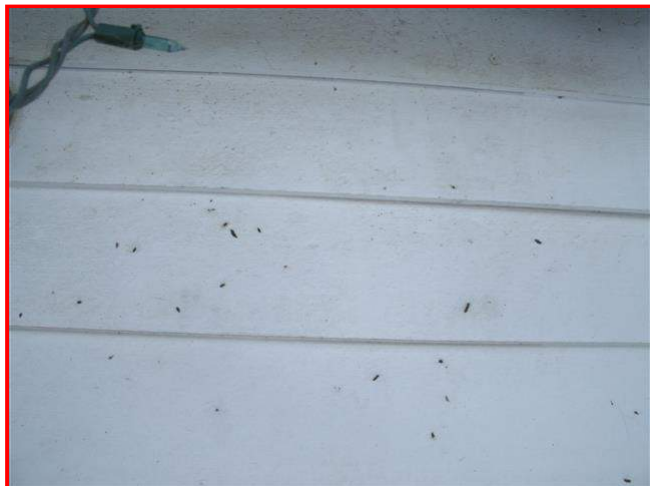
2.4 Item 2(Picture)

- 🐿 (2) Black spots on siding appear to be bat droppings. There appear to be bats in the attic. Recommend consulting with a pest control agent.

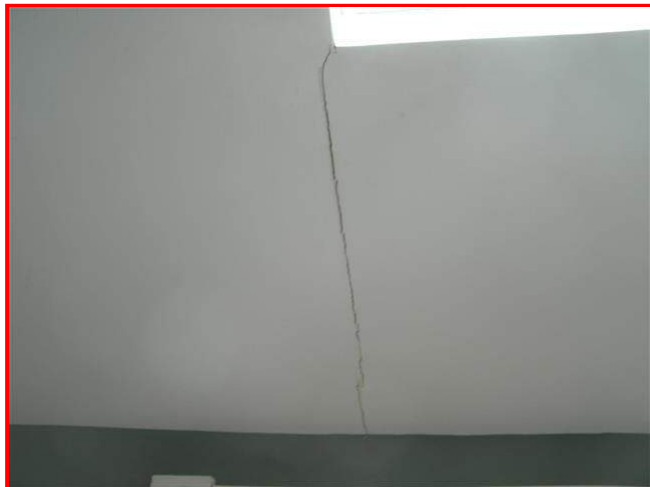
5.0 Item 1(Picture)

- Minor crack from previous leak. Recommend monitoring for further movement.

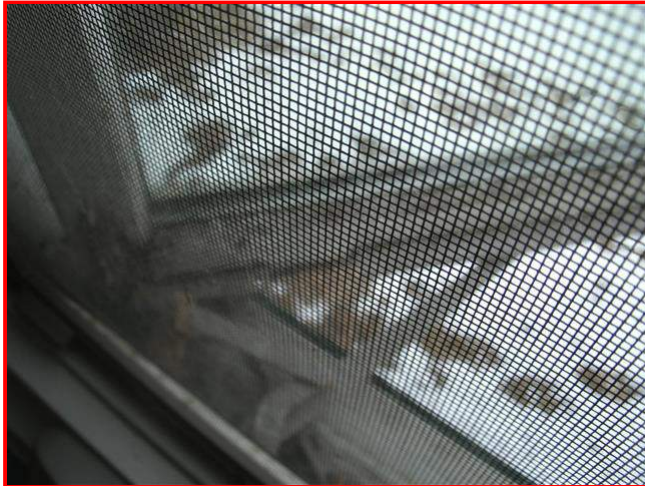
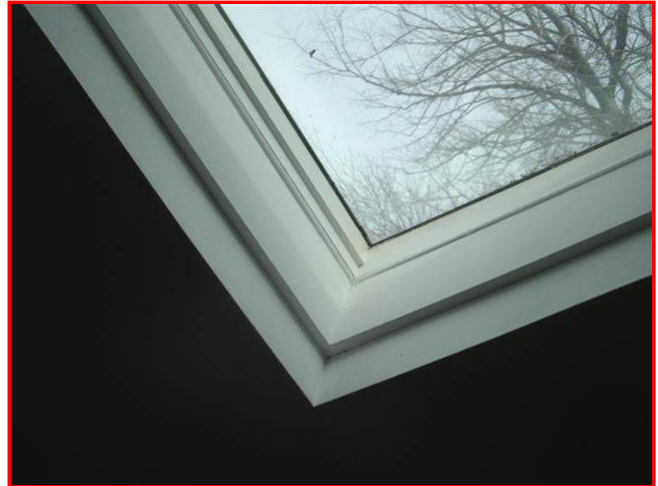
5.6 Item 1(Picture)

- Damage to wood from window being left open in the rain. Recommend sanding and painting by a qualified painter.

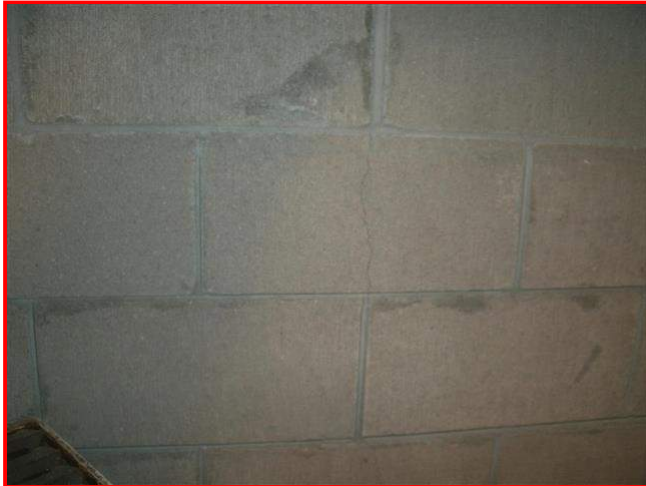
7.1 Item 1(Picture)

Minor cracks in basement wall. Recommend monitoring for further movement.

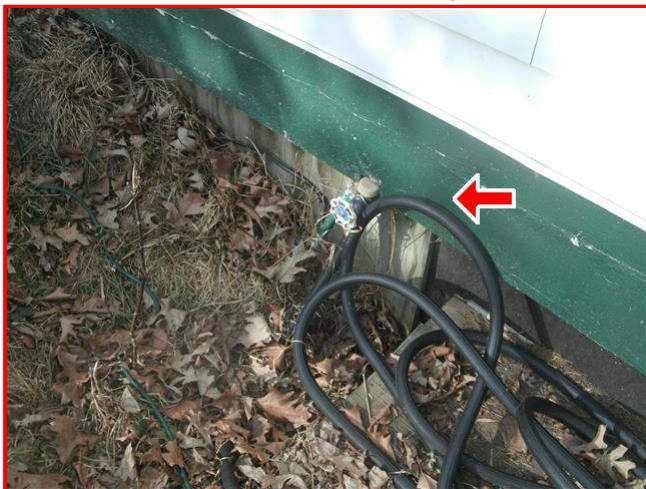
8.1 Item 1(Picture)

- ⚠ Don't leave hoses attached to outside faucet when not in use. Winter weather can freeze pipes inside the house, and summer heat can promote microbial growth.

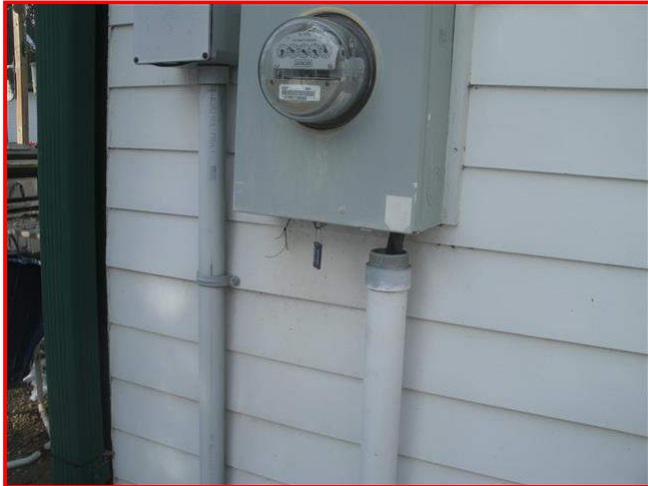
10.0 Item 1(Picture)

- ⚠ (1) Raceway for elect. service is loose. This is caused by frost heave. Recommend repair by qualified person.

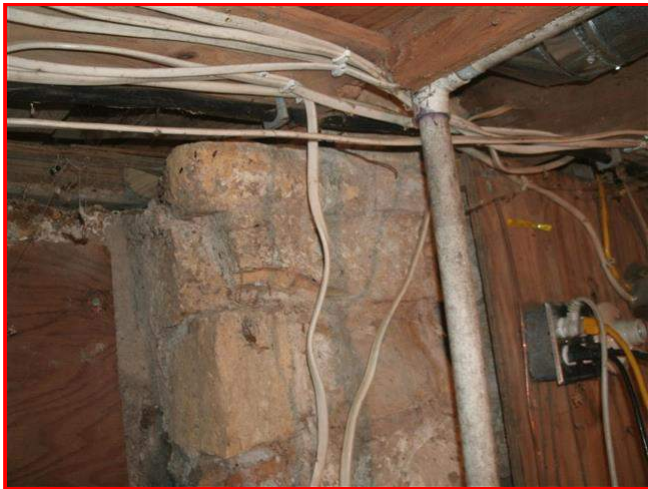
10.0 Item 2(Picture)

(2) Loose and unsupported Romex can get damaged and create fire and shock hazard.

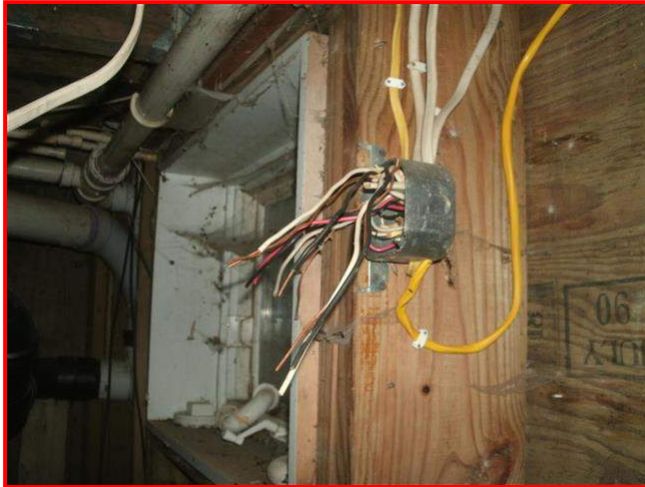
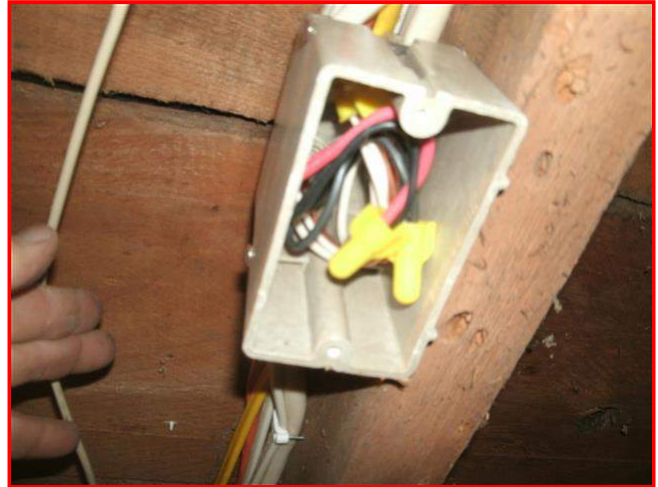
10.3 Item 1(Picture)

- ⚡ (1) Loose and exposed wiring presents shock and fire hazard. Recommend repair by qualified electrician.

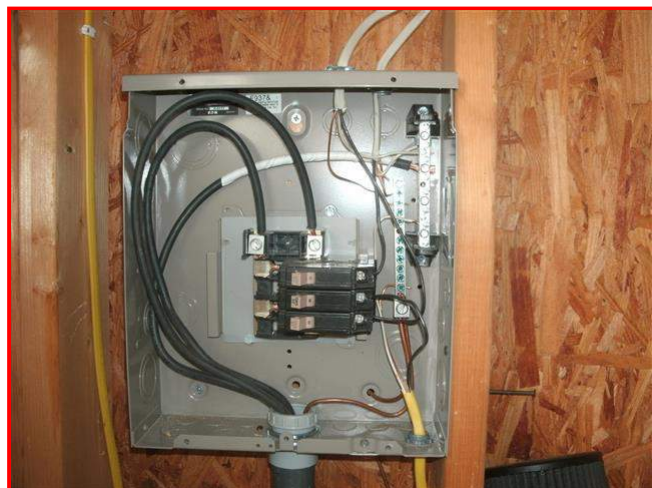
10.3 Item 4(Picture)

- ⚡ (2) Sub panel in garage is properly installed.

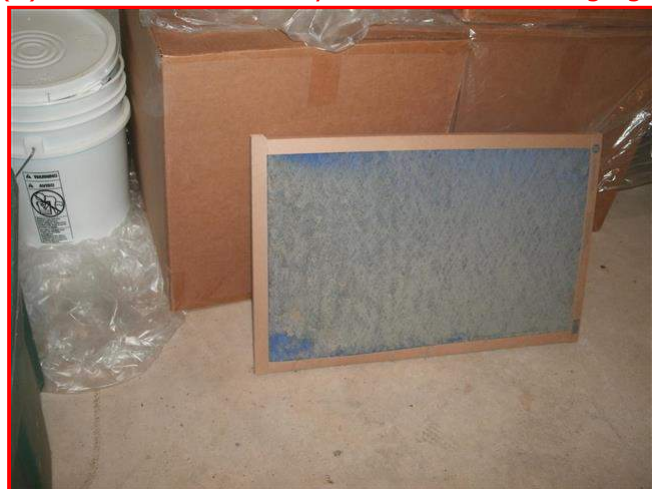
11.0 Item 1(Picture)

- (1) Furnace filter is dirty. Recommend changing filter every month.

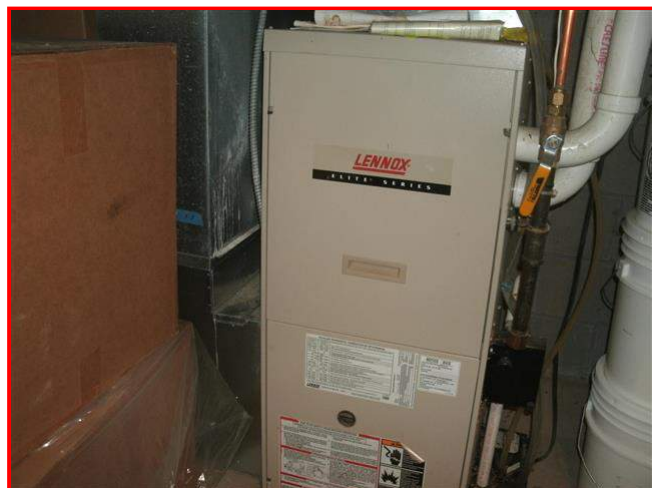
11.0 Item 2(Picture)

- (2) Furnace is 12 years old. While operational, funds should be set aside for eventual replacement.

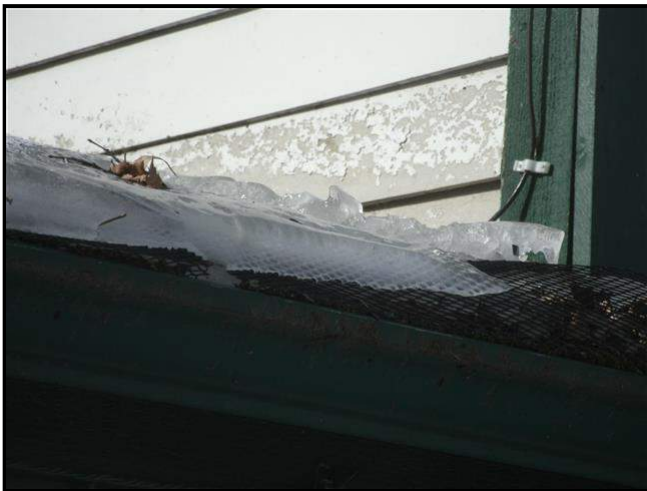
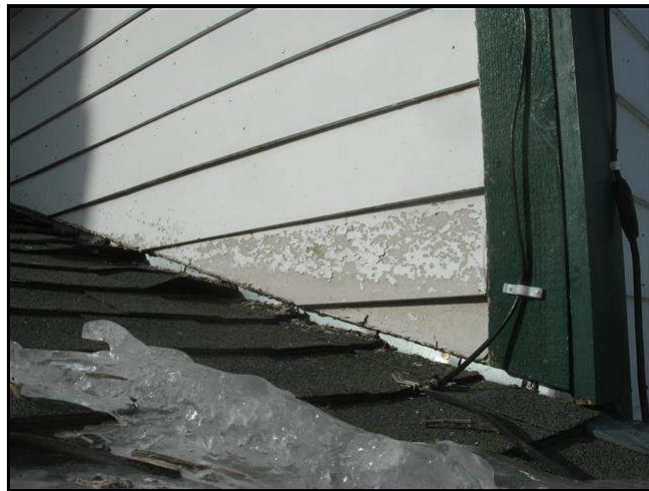
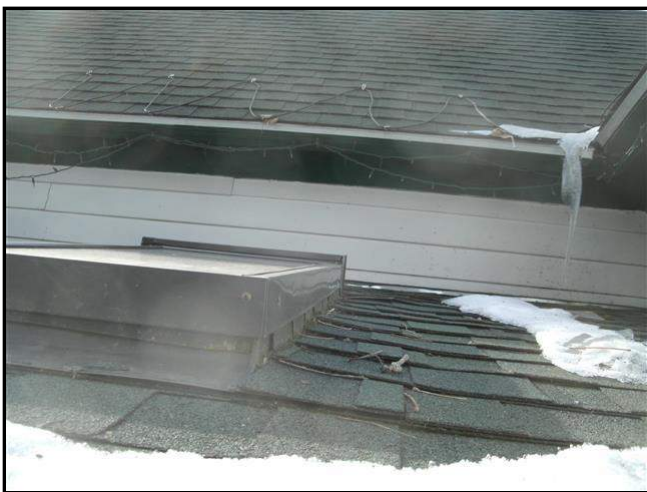
1.0 Item 1(Picture)

1.0 Damaged siding should be replaced or repaired.

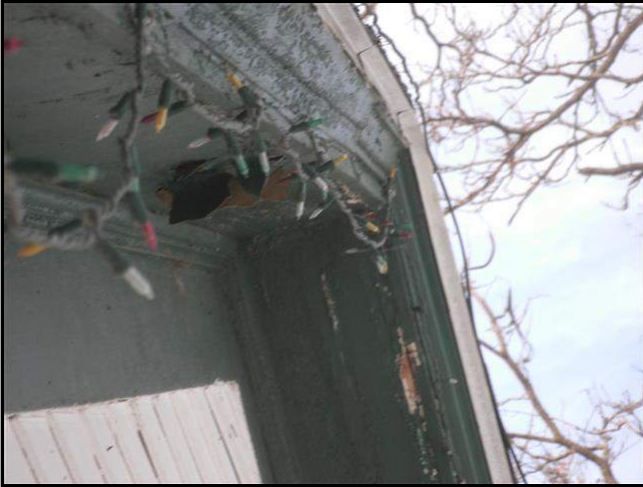
1.1 Item 1(Picture)

🔧 **1.1** (1) The siding is weathered due in part to build up of snow in previous winters. Recommend repairing damaged siding and installing kick out flashing. Hardi-Plank requires 6' clearance above flat surfaces.

🔧 (2) Insect damage in soffit in front of house. further damage could occur if repairs are not made. Recommend repair by qualified person.

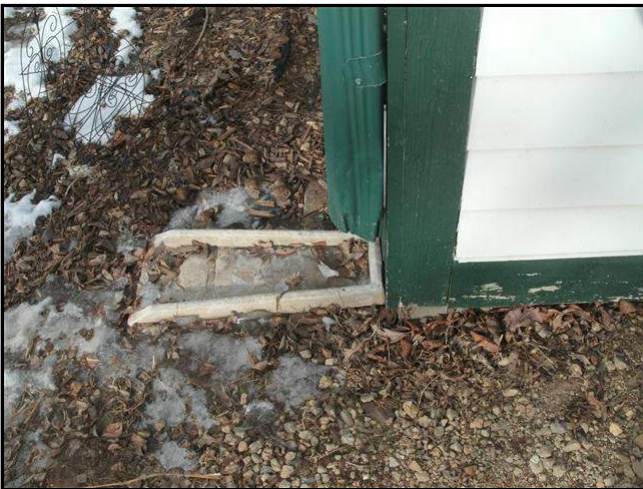
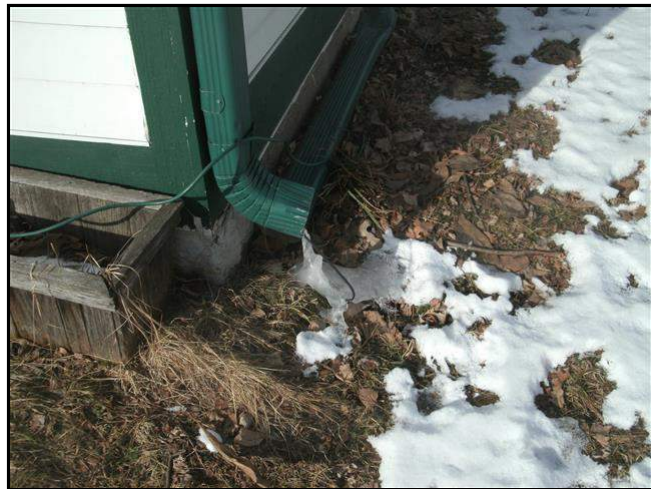
1.3 Item 1(Picture)

🔧 **1.3** The downspout missing part (S) at the front (left of main entry). Erosion can continue or become worse if not corrected. A qualified person should repair or replace as needed.

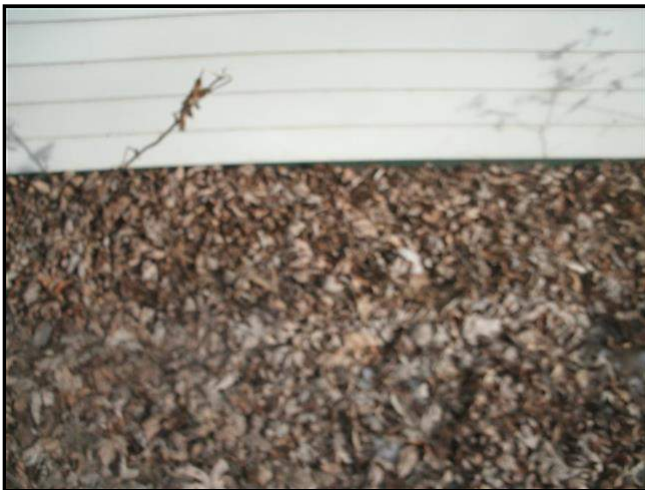
2.0 Item 1(Picture)

2.0 Siding should be 6" above grade. Recommend creating swale and removing soil from base of exterior walls.

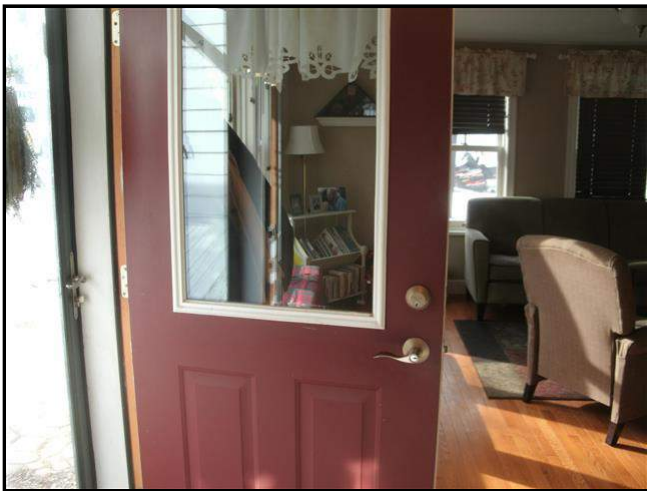
2.1 Item 1(Picture)

2.1 Steel and glass front door.

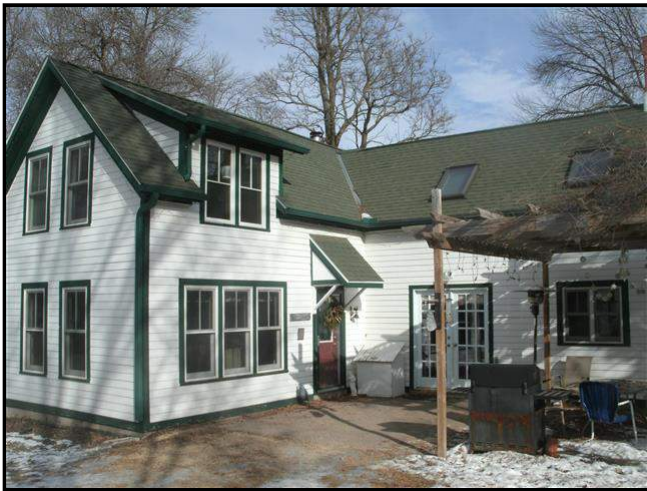
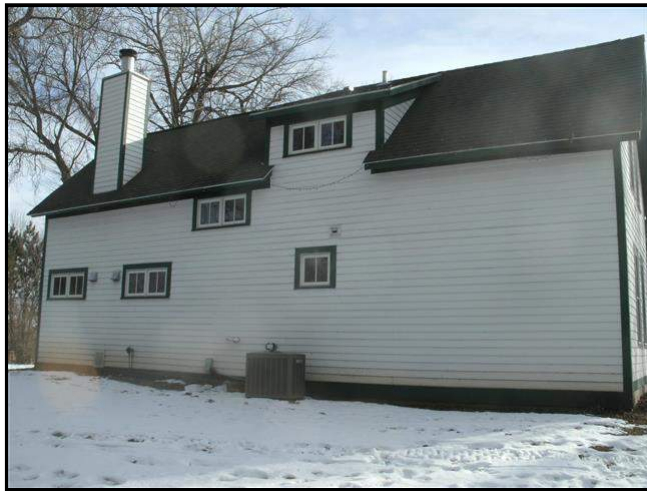
2.2 Item 1(Picture)

2.2 Windows are functional, and have working locks.

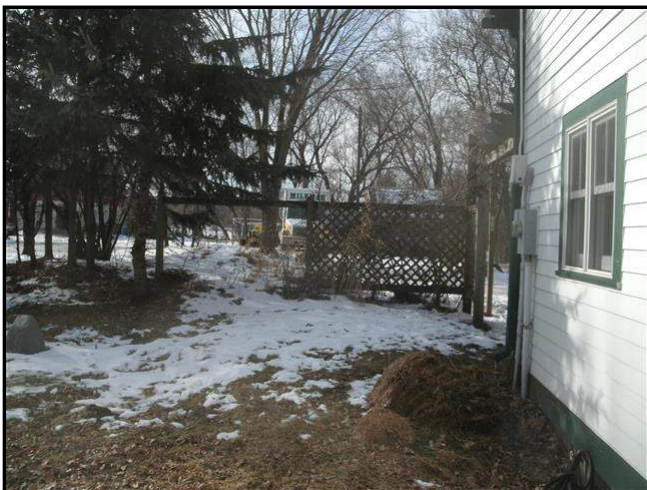
2.4 Item 1(Picture)

👉 2.4 (1) There is a negative slope at the left side (facing front) and can cause or contribute to water intrusion or deterioration. I recommend correcting landscape to drain water away from home.

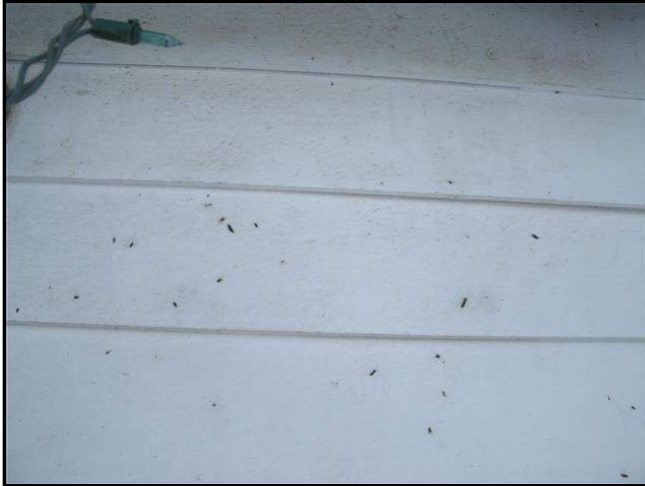
2.4 Item 2(Picture)

🔧 (2) Black spots on siding appear to be bat droppings. There appear to be bats in the attic. Recommend consulting with a pest control agent.

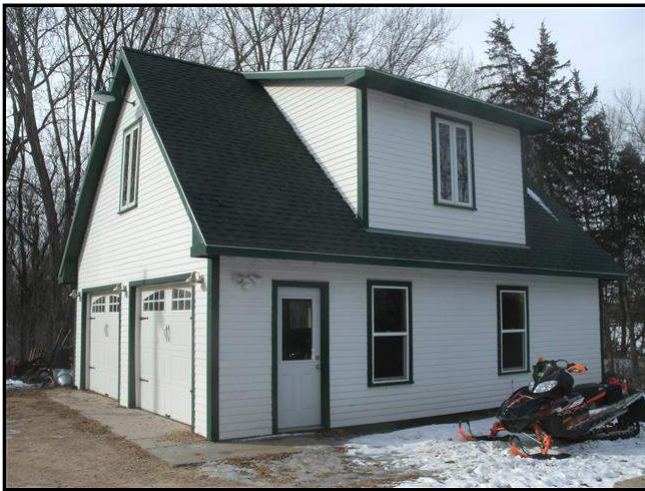
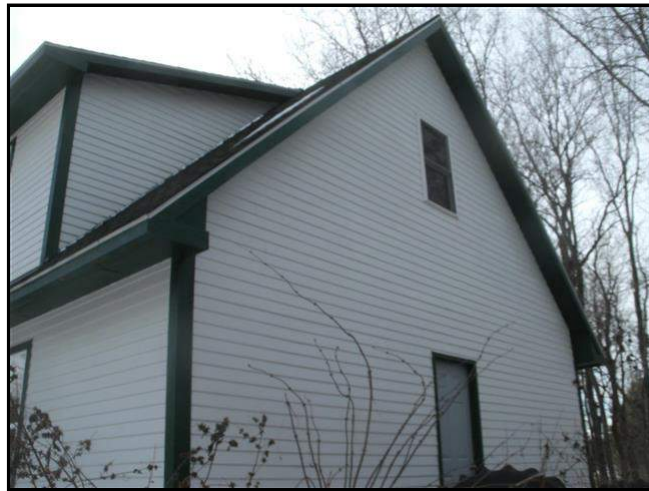
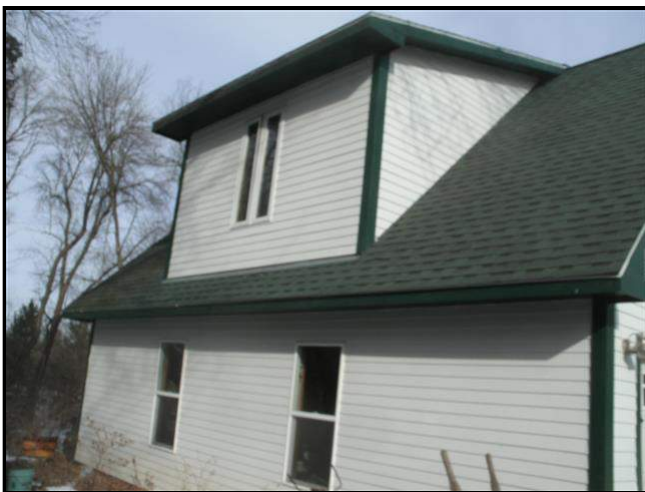
3.0.B Item 1(Picture)

3.0.B Garage siding appears to be properly installed.

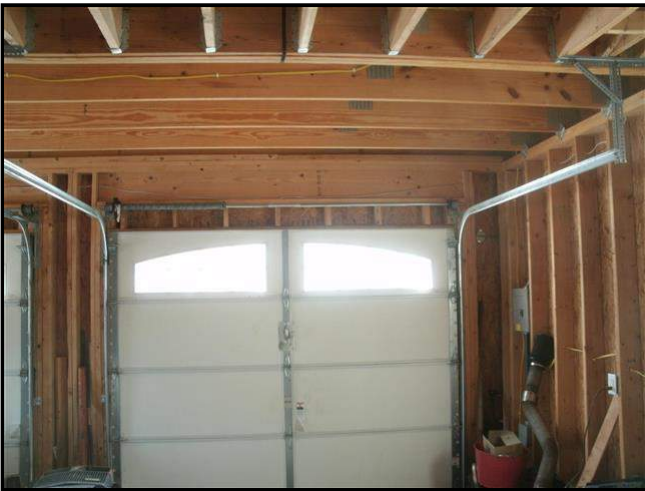
3.3.B Item 1(Picture)

3.3.B Garage doors don't have openers.

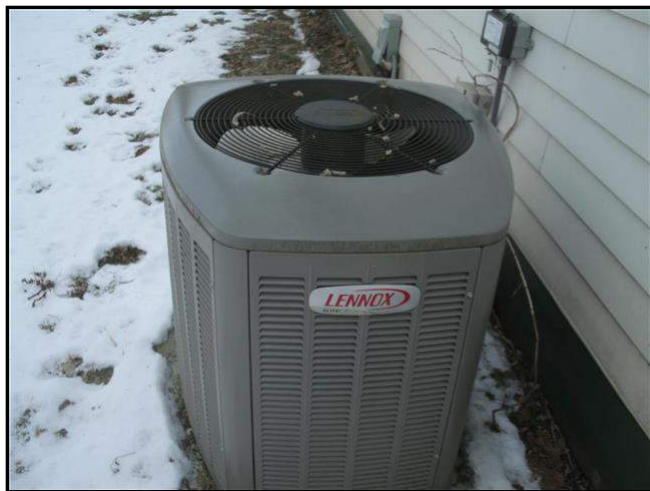
4.0 Item 1(Picture)

4.0 (1) A/C unit is properly installed.

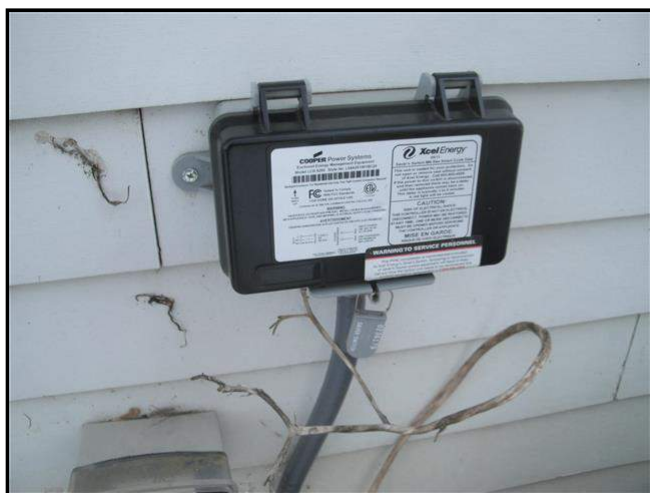
4.0 Item 2(Picture)

(2) Energy saver switch will save money during summer months.

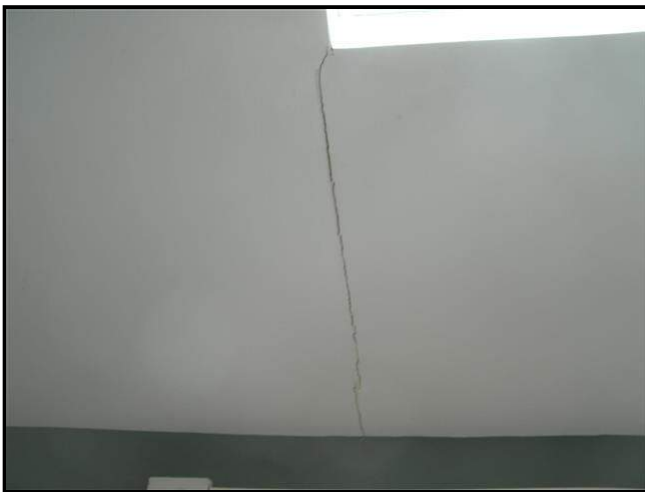
5.0 Item 1(Picture)

🔧 **5.0** Minor crack from previous leak. Recommend monitoring for further movement.

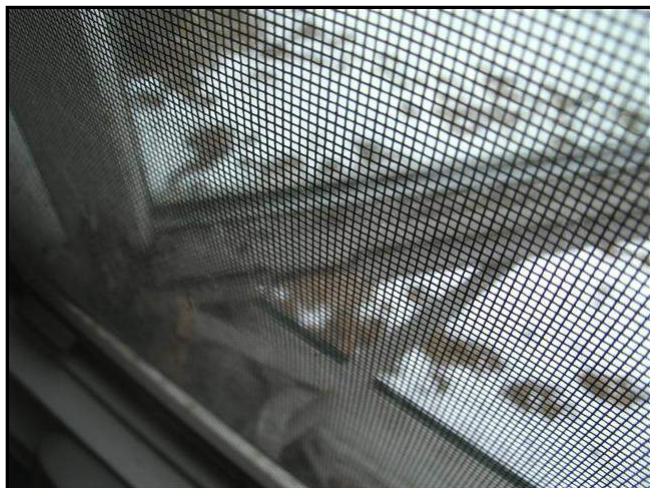
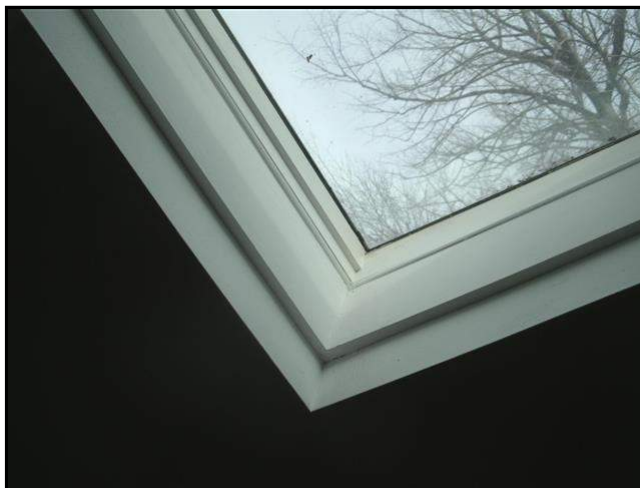
5.6 Item 1(Picture)

🔧 **5.6** Damage to wood from window being left open in the rain. Recommend sanding and painting by a qualified painter.

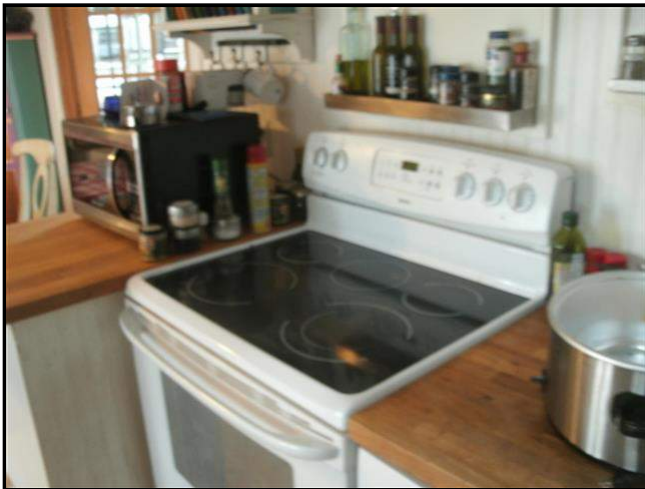
6.0 Item 1(Picture)

6.0 Stove should have anti-tip device installed, to keep stove from tipping forward.

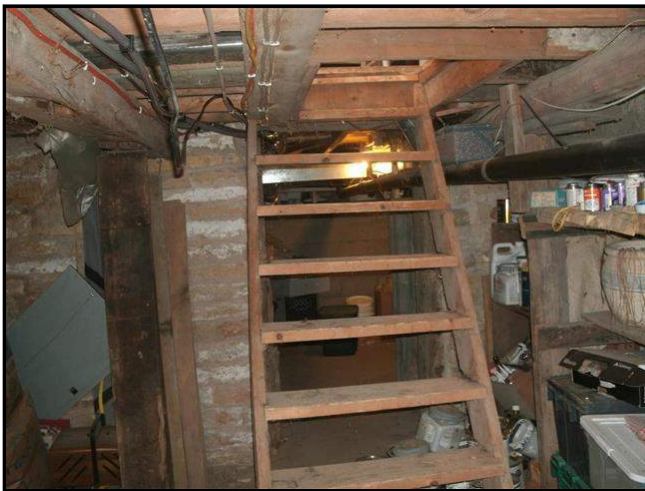
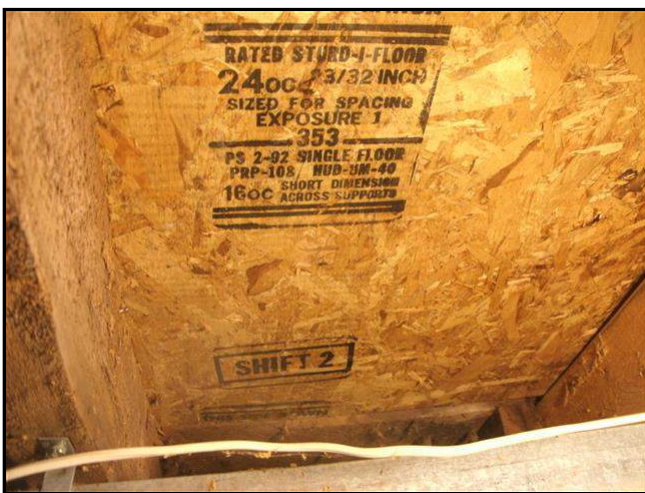
7.0 Item 1(Picture)

7.0 Care should be taken when entering the basement.

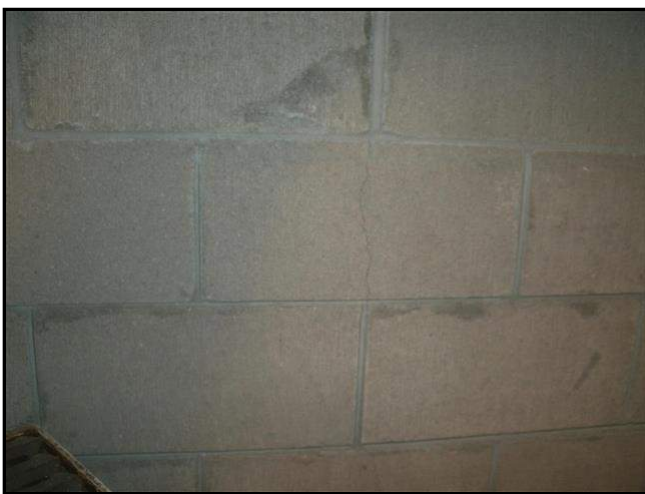
7.1 Item 1(Picture)

7.1 Minor cracks in basement wall. Recommend monitoring for further movement.

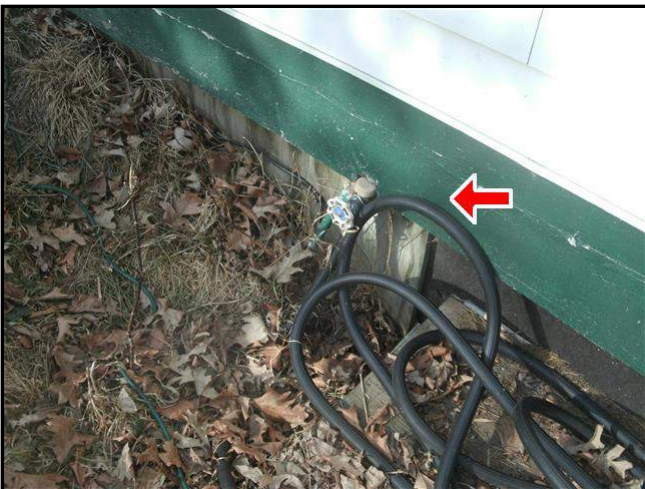
8.1 Item 1(Picture)

8.1 Don't leave hoses attached to outside faucet when not in use. Winter weather can freeze pipes inside the house, and summer heat can promote microbial growth.

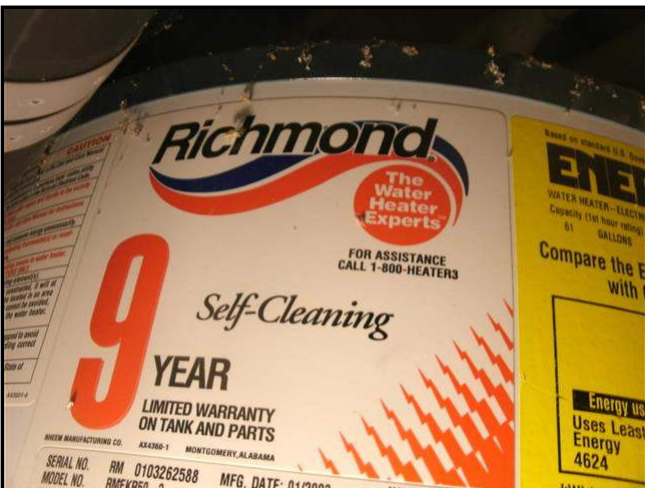
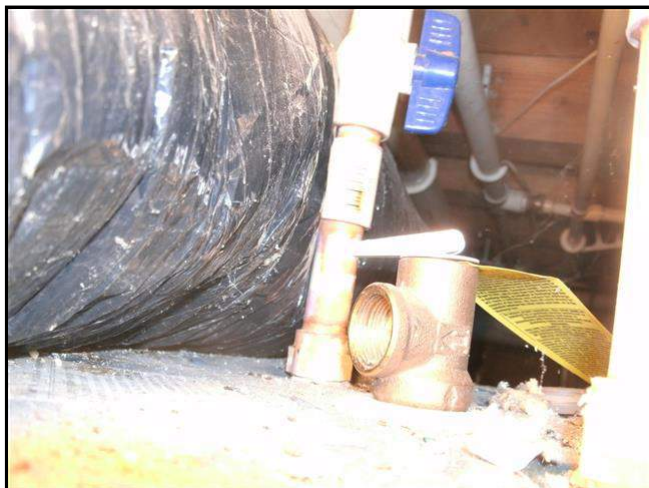
8.2 Item 1(Picture)

8.2 Water heater is missing TP valve extension.

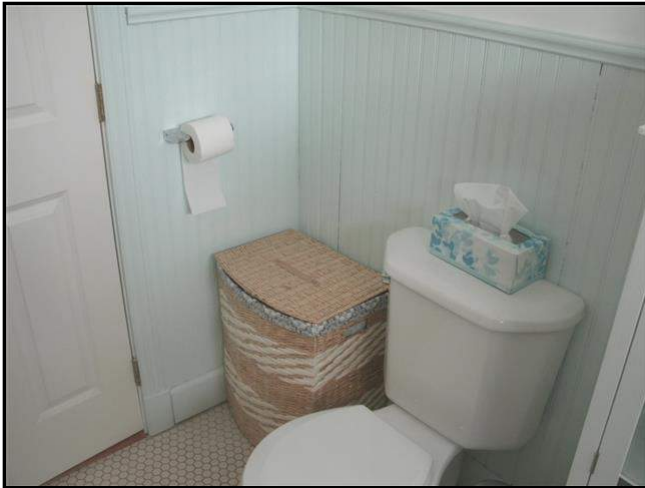
9.0 Item 1(Picture)

9.0 Upstairs bathroom.

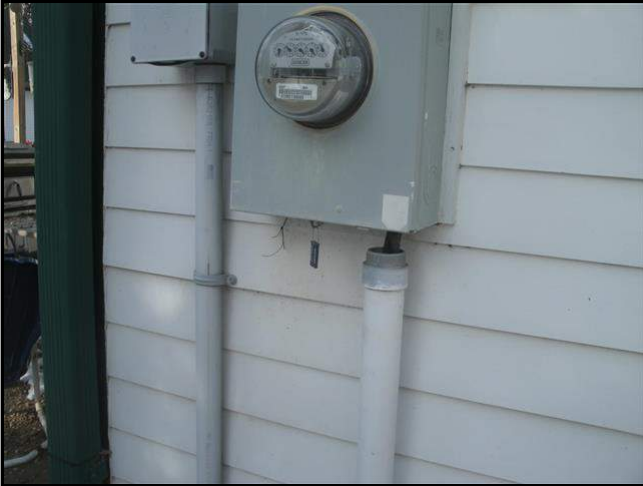
10.0 Item 1(Picture)

🔧 10.0 (1) Raceway for elect. service is loose. This is caused by frost heave. Recommend repair by qualified person.

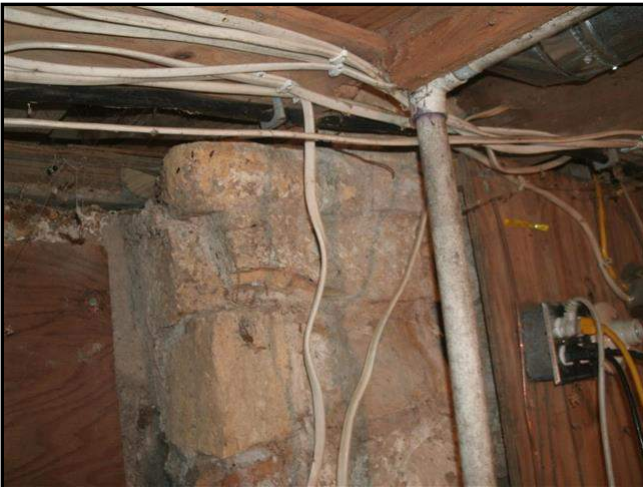
10.0 Item 2(Picture)

🔧 (2) Loose and unsupported Romex can get damaged and create fire and shock hazard.

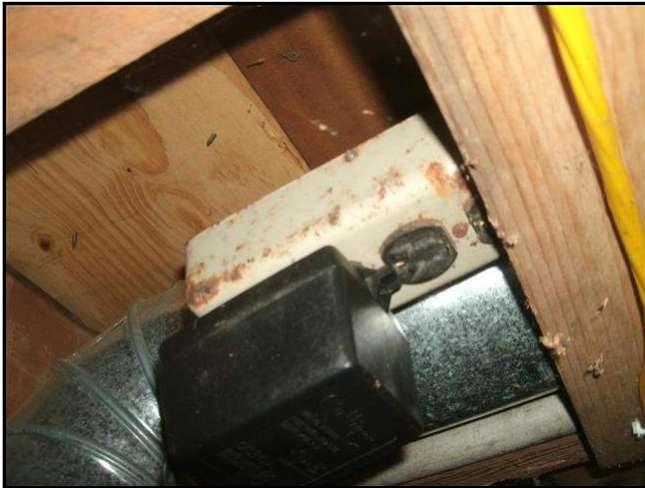
10.0 Item 3(Picture)

(3) Water softener is plugged into extension cord. Recommend replacing extension cord with receptacle, which is safer.

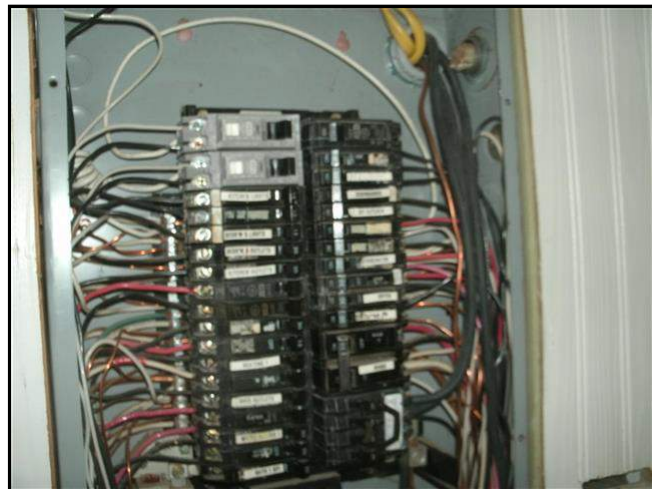
10.1 Item 2(Picture)

10.1 (1) Be sure to keep area in front of panel clear.

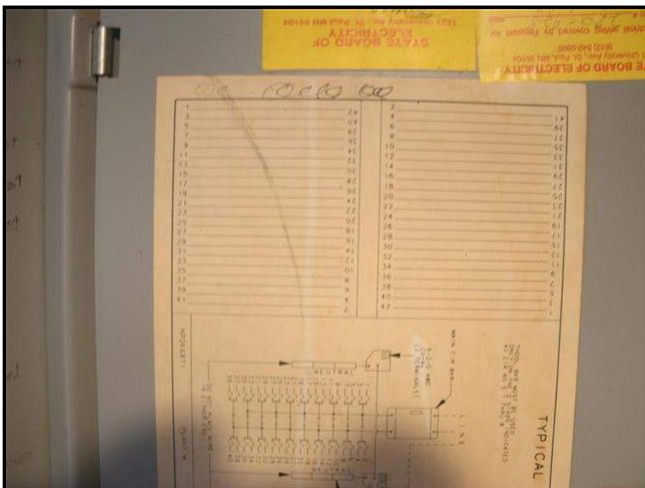
10.1 Item 3(Picture)

(2) Recommend clearly indicating the circuits and breakers on index inside panel door.

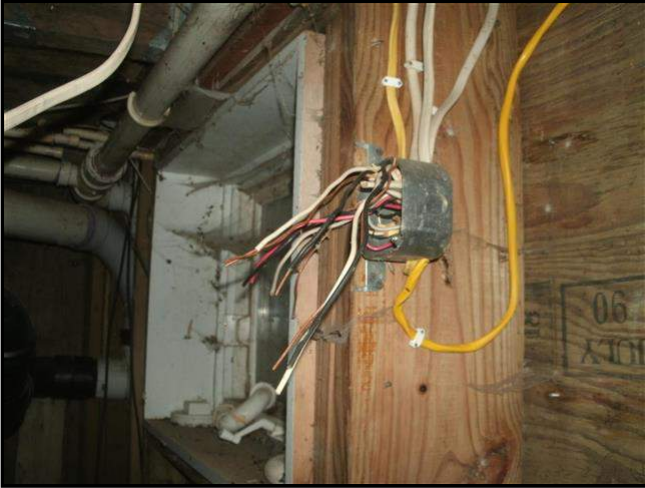
10.3 Item 1(Picture)

🔧 **10.3 (1)** Loose and exposed wiring presents shock and fire hazard. Recommend repair by qualified electrician.

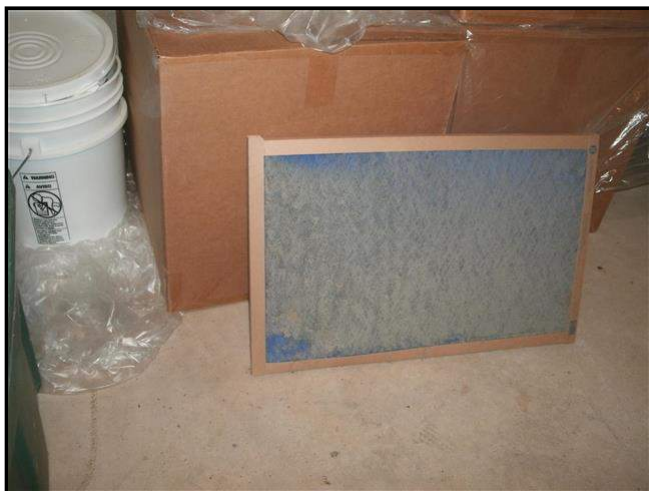
11.0 Item 1(Picture)

🔧 **11.0 (1)** Furnace filter is dirty. Recommend changing filter every month.

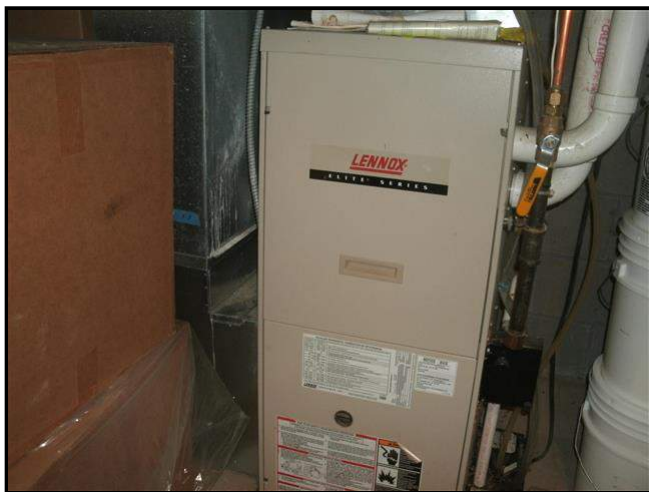
11.0 Item 2(Picture)

🔧 **(2)** Furnace is 12 years old. While operational, funds should be set aside for eventual replacement.

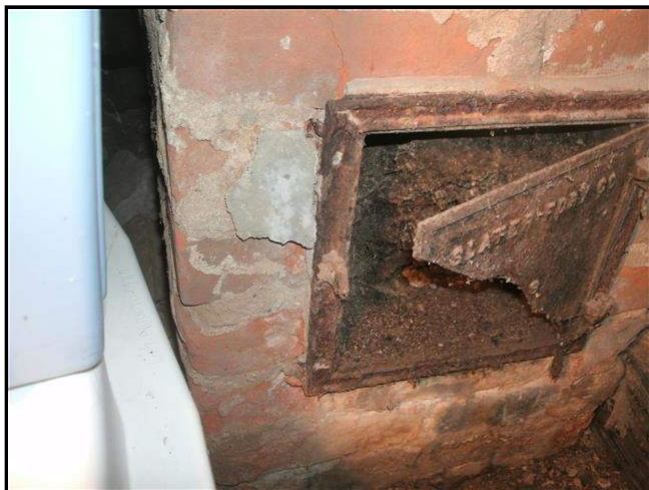
12.0 Item 1(Picture)

- 12.0** (1) I recommend that all wood fireplaces be cleaned and inspected yearly by a qualified chimney sweep.
 (2) Clean out door is rusting and damaged. Recommend replacing.
